REDUCING 'FAILED TO DETECT' CRASHES AT RURAL CROSSROADS

Document Title: Reducing ‘failed to detect’ crashes at rural crossroads

Prepared for: AA Research Foundation

Prepared by: Mackie Research

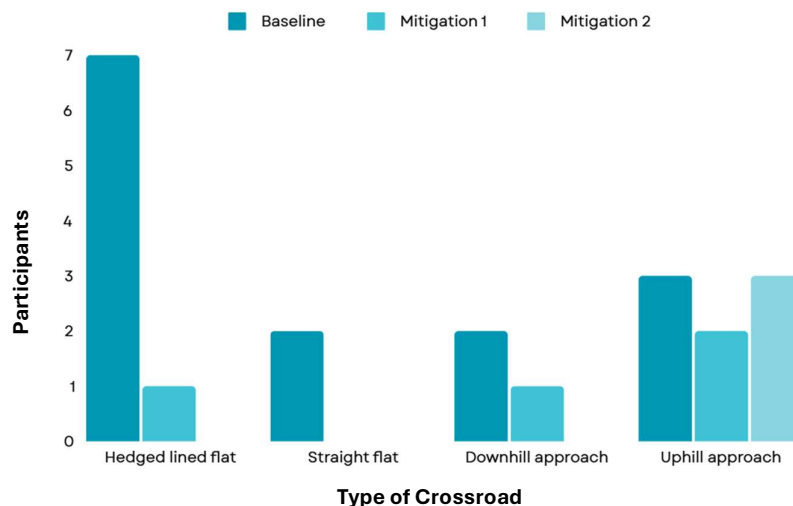
Number of participants who saw the intersection dangerously late (within 100m)

The addition of commonly available TCDs saw a dramatic improvement in the detection of most crossroads. Although, interestingly, the addition of a white backing board on Stop warning signs led to sign recognition uncertainty for some participants.

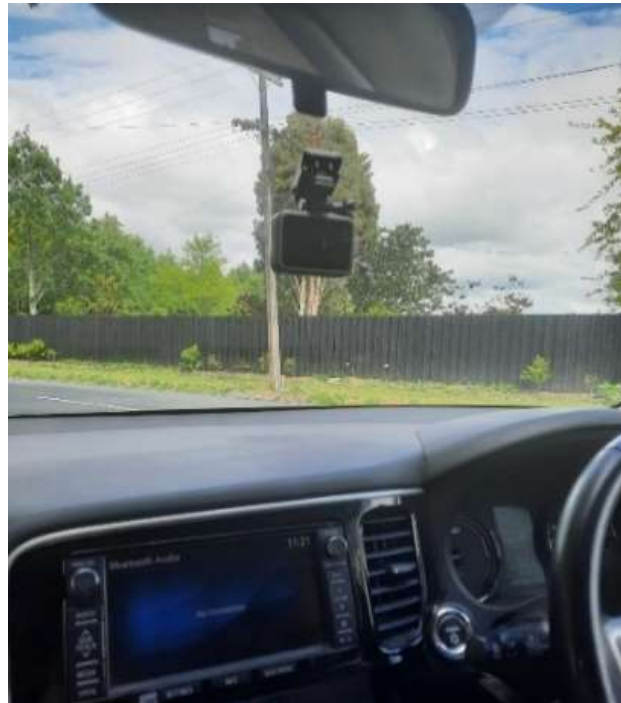
Figure 4: Video camera positioning.

Filming took place during daylight hours and in good weather. At each crossroad site, a route of approximately 5 minutes was filmed, with at least 3 minutes of driving prior to arriving at the crossroad. The filming vehicle travelled at a target speed of approximately 80km/h. This was based on testing prior to filming where the team found that this speed provided the most 'realistic' impression of general rural travel speeds when presented on screen.

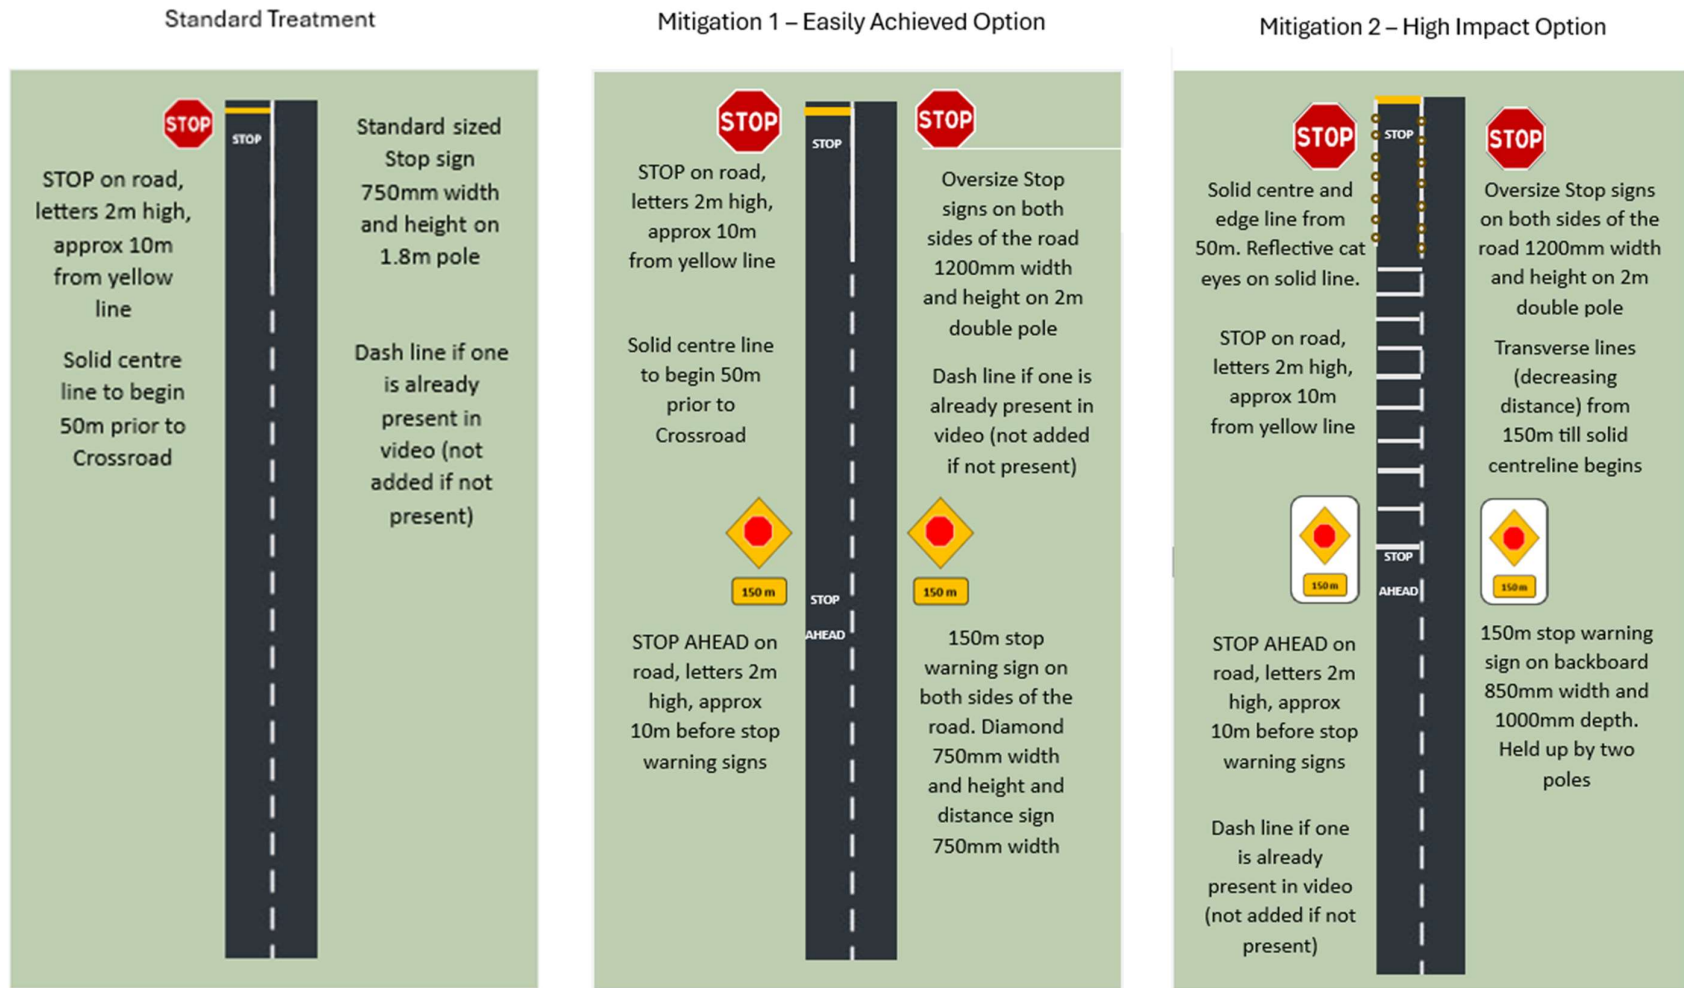
Figure 5: Crossroads trial conditions.

Figure 5 details each mitigation condition, Figure 6 shows an example of mitigations created through video augmentation at one site. For standard treatments, additional signage and markings were digitally removed from the video to achieve the specifications in Figure 5. However, centreline markings were retained as they were videoed onsite because, depending on the nature of the road, approaches to crossroads may, or may not, have centrelines present. The team wished to have both options included in the trial.

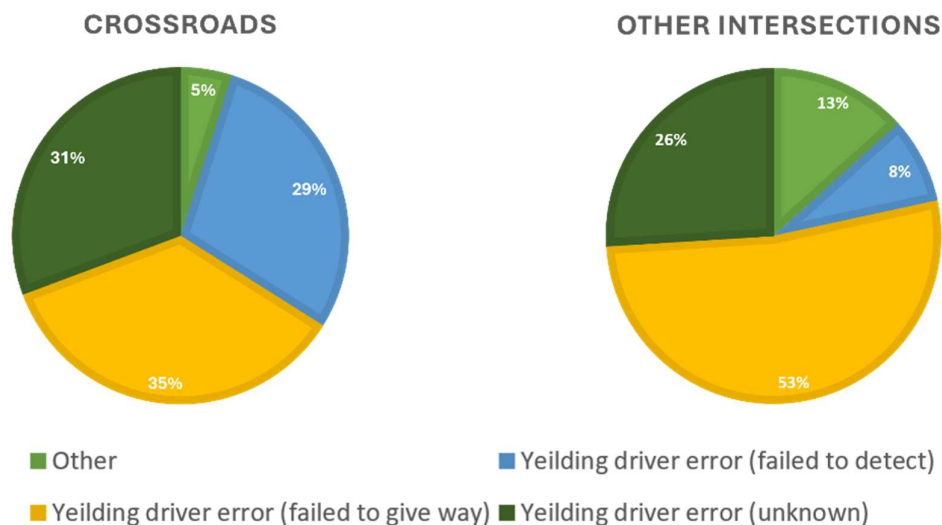
Figure 8: Crash causes at crossroads compared to other intersections.

Figure 8 shows the comparison of crash causes between crossroads and other intersection types.

A comparison between crossroads and other rural intersections shows that many more 'failed to detect' crashes occur at rural crossroads (29% of crashes reviewed compared to 9% for other intersections). This suggests that there are some features of rural crossroads that make these types of crashes more likely. To better understand the characteristics of 'failure to detect' crashes at rural crossroads, a more detailed Safe System/ Human Factors analysis was undertaken. The results are presented in the following section.

Results for crashes where sufficient information was available to code a crash cause show that 'failure to detect' crashes do occur at all intersection types. This dataset only included fatal and serious crashes. It is likely that more, less serious, 'failure to detect' crashes also occur at rural intersections or that failing to detect the crossroad results in no crash because an intersecting vehicle isn't approaching by chance.

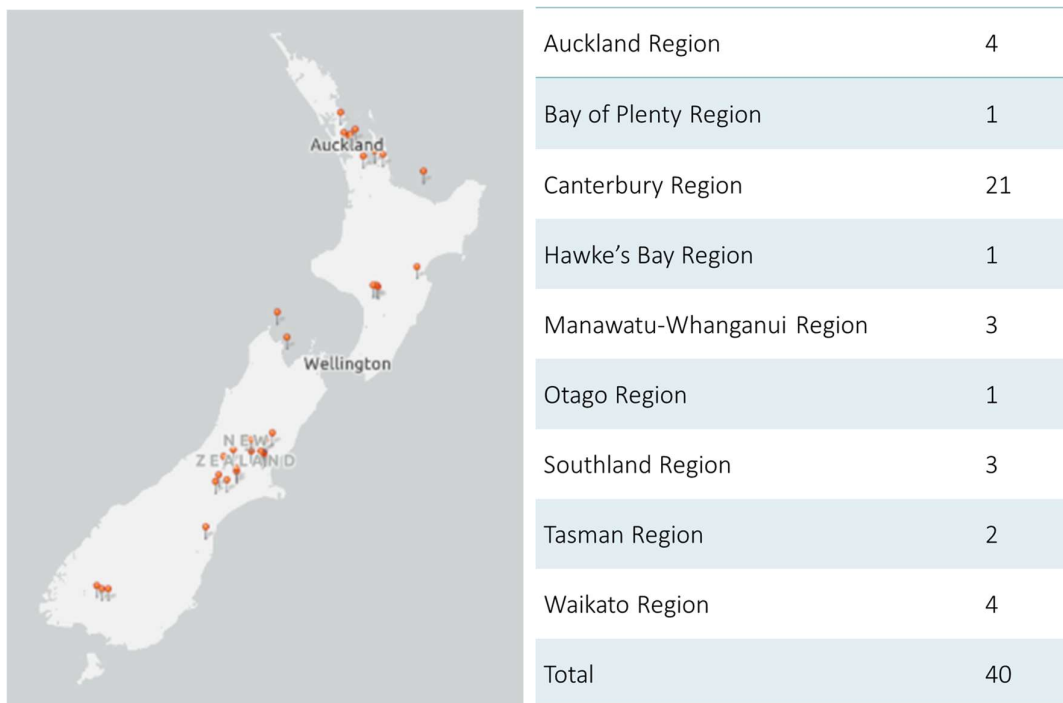
Figure 9: Location of 'failed to detect' crossroads crashes

In terms of road type, the majority of crashes occurred on medium or minor rural roads (32) with only a few occurring on major rural roads (5) or rural arterials (3). This suggests that crashes are occurring on roads with lower volumes of traffic, likely without the visual cues of intersecting traffic ahead. Potentially, these roads may also be less likely to have additional treatments (such as signage and markings) as they may not be considered high risk.

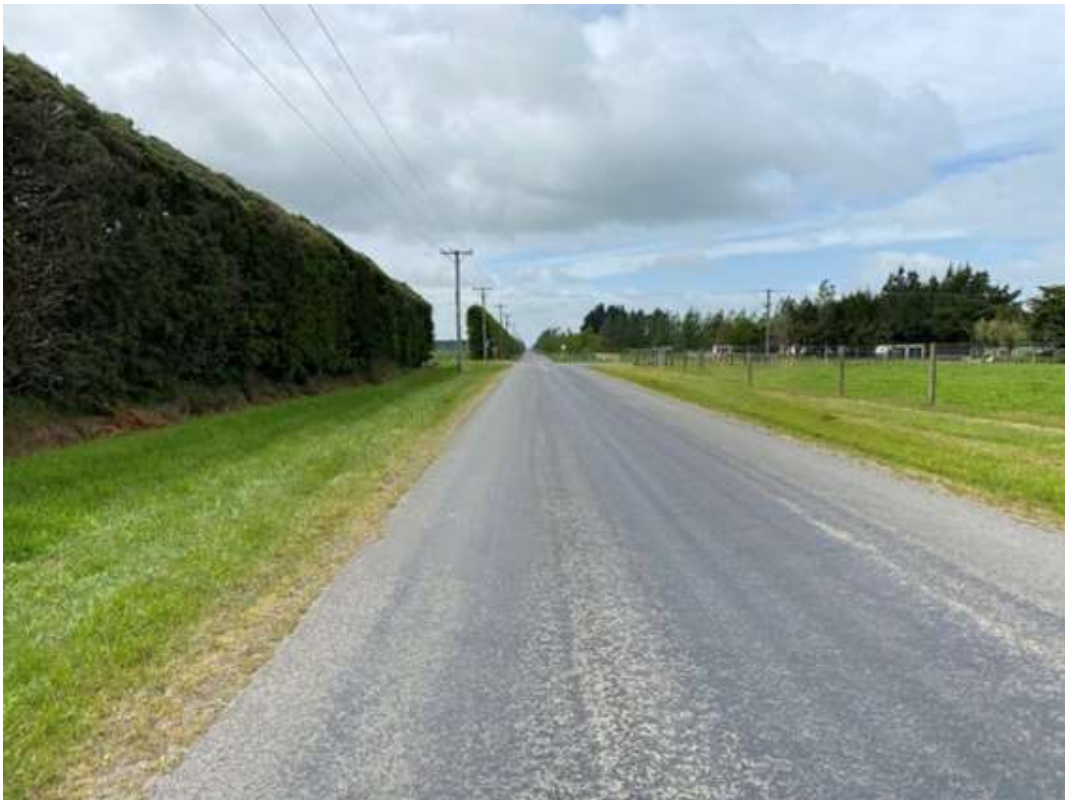
Figure 11: Example of continuity cues (hedge) at a site in Canterbury

The road environment at the crossroad itself is also a potential factor in ‘failure to detect’ crashes, for example, if the priority road is difficult to see, or the road appears visually to continue on straight ahead.

These results clearly suggest that, in terms of road geometry, there are specific conditions under which failing to detect a crossroad is more likely. When combined with the broader general environmental results described previously, which may lead a driver to be less attentive, a picture emerges of the situations under which errors are more likely.

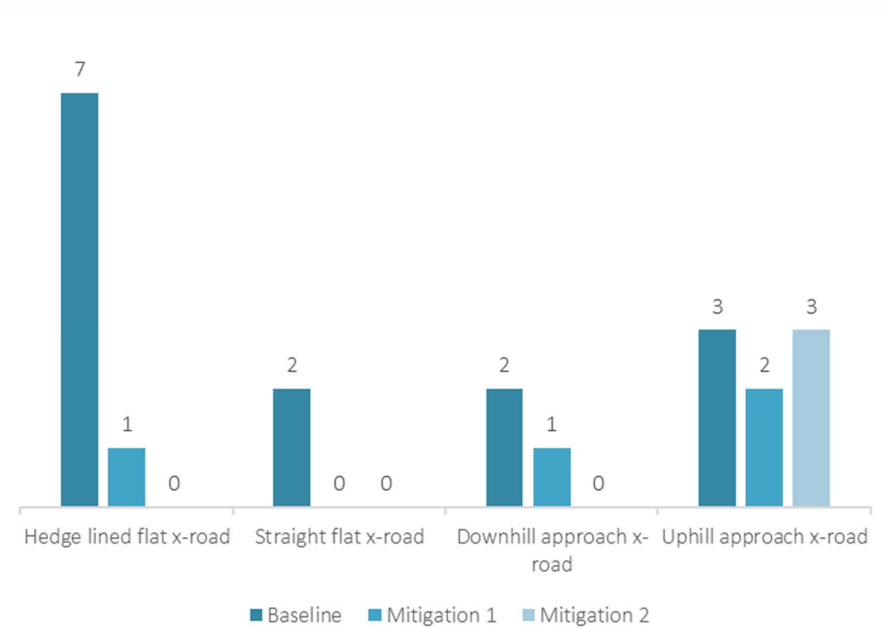
Figure 12: Number of participants who indicated they needed to stop or give way within the 'danger zone' of less than 100m prior to the crossroad.

Table 3 shows that at three sites, participants indicated that they knew that they needed to stop or give way ahead significantly earlier when Mitigations 1 or 2 were presented, compared to the baseline condition. This result highlights the importance of advanced warning signage and possibly also oversized gated Stop signs.

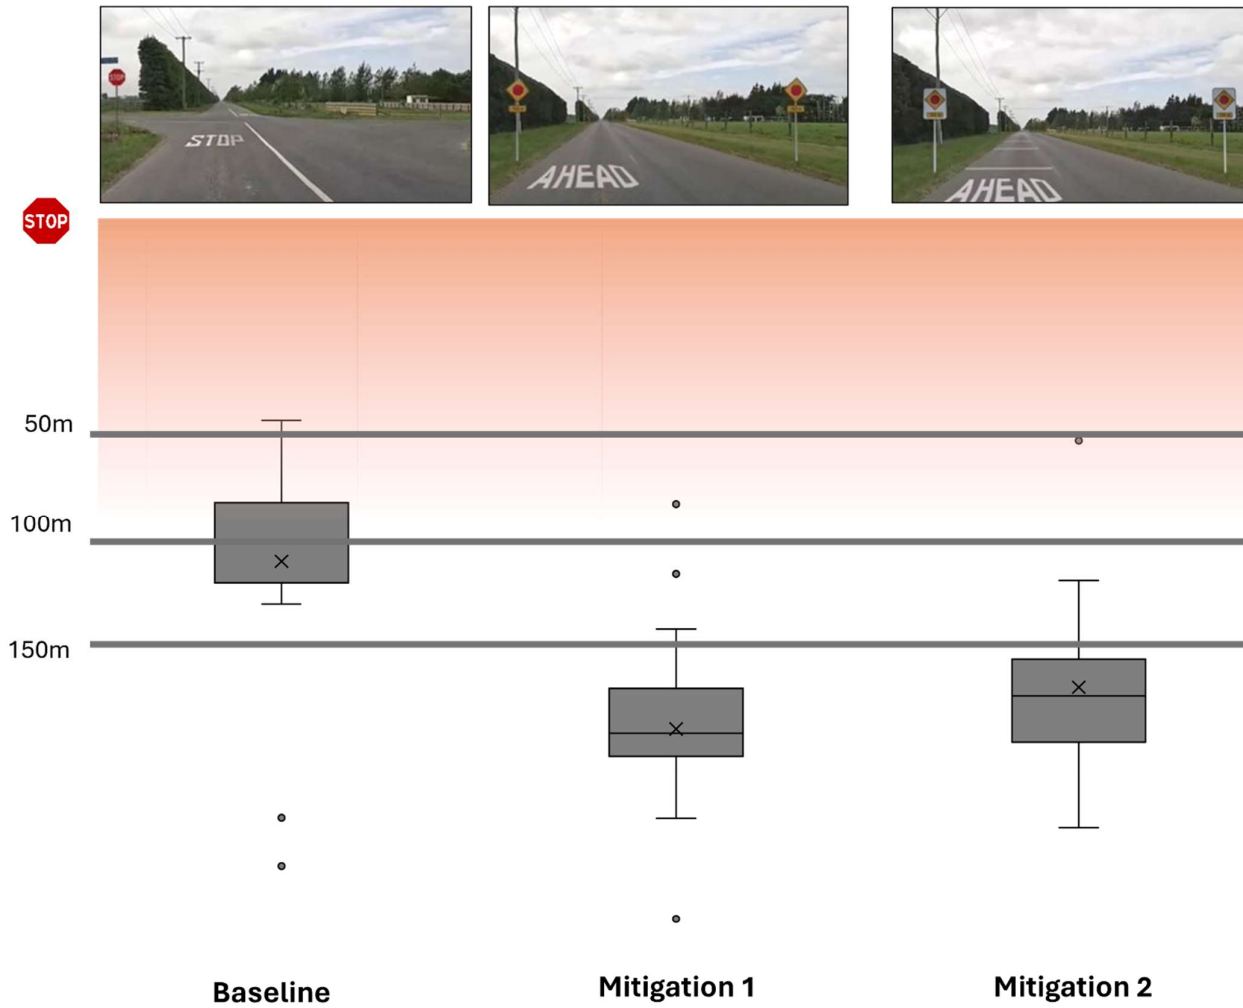
As Figure 14 shows, both mitigations had the desired effect of moving back the distance where participants indicated that they knew they needed to stop or give way to a safe distance from the crossroad in almost all cases (only 6%, one participant, was within the 100m danger zone for Mitigation 1). Interestingly, there was little difference in the effectiveness of the two mitigations. This is even though Mitigation 2 is more visually obtrusive. This result suggests that in normal driving conditions standard warning signs and oversize stop signs may be sufficient to alert most drivers to the presence of the crossroad.

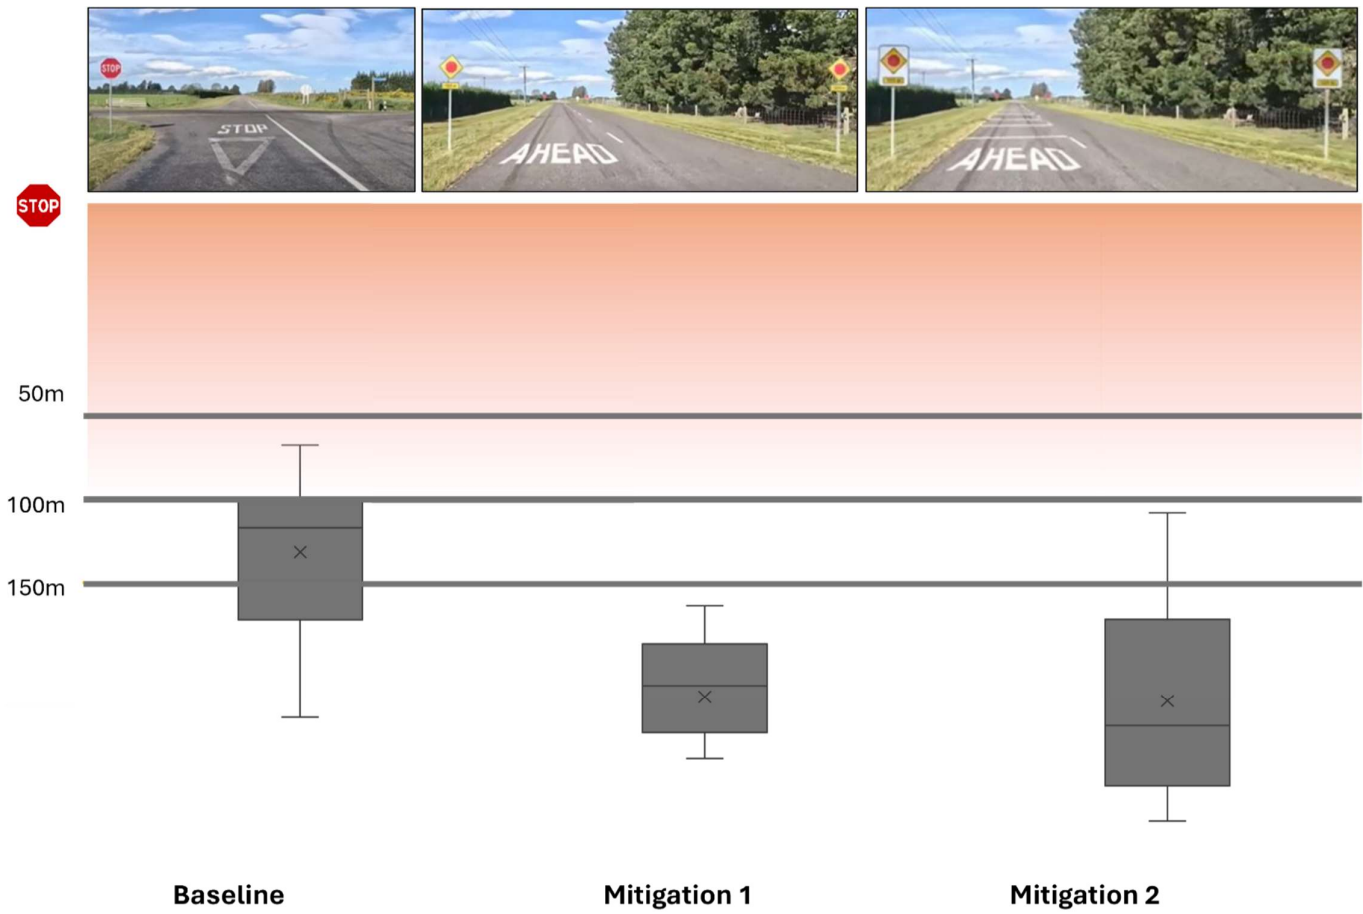
In addition, the results may highlight the impact of unfamiliar signage on driver understanding of the road ahead. Given the obtrusive nature of Mitigation 2, it is possible that some participants were aware of the signs some time before they realised that they indicated that they should stop or give way. If this is the case, while the signs attracted attention, they may also have served as something of a distraction while participants worked out what they meant.

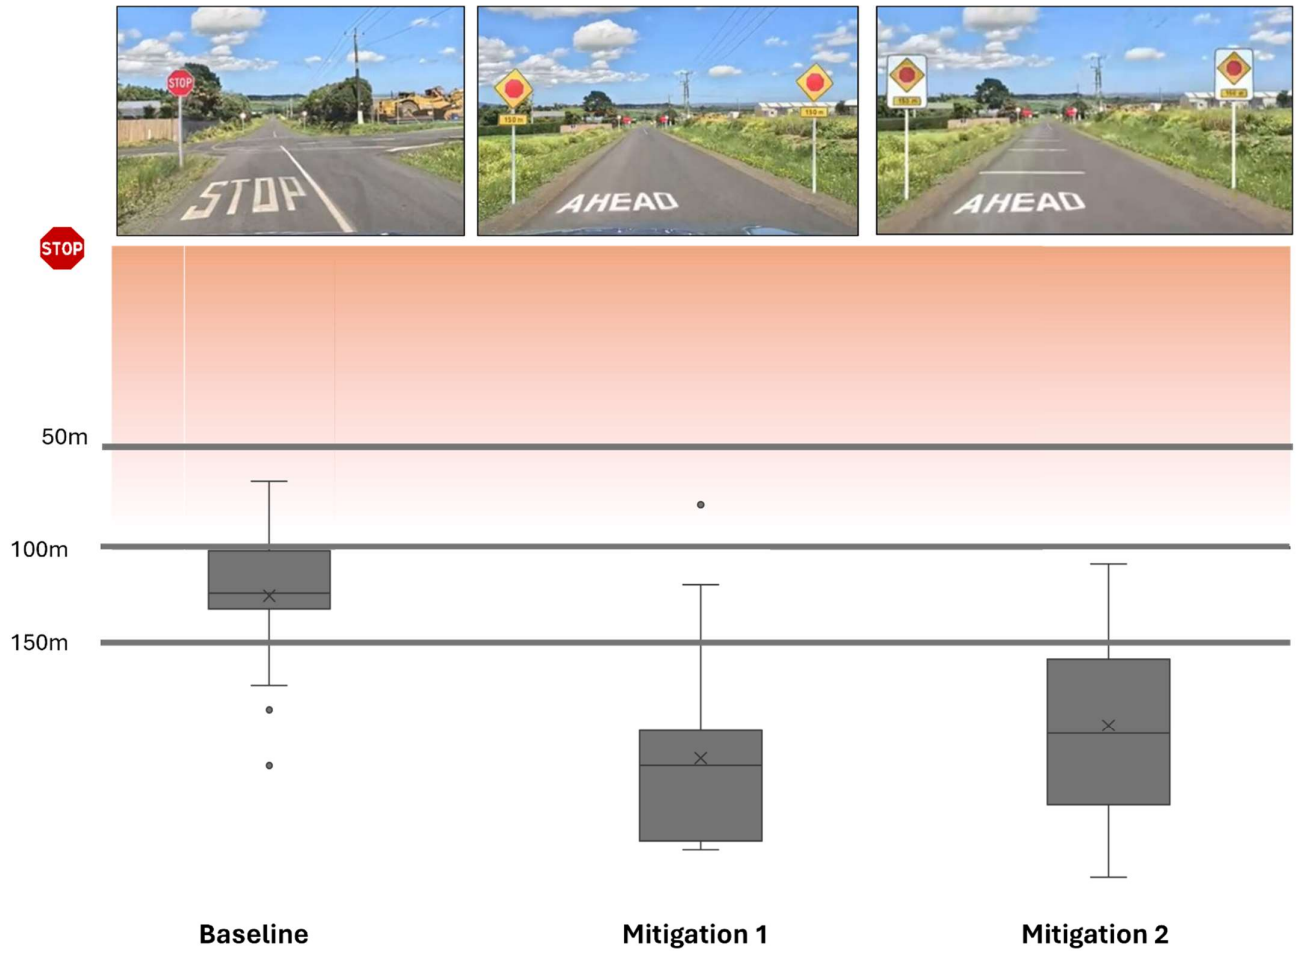
Overall, Mitigation 1 was more effective than Mitigation 2.⁷ As mentioned previously, it may be that the novelty of the signs in Mitigation 2 attracted participants attention but didn’t provide them with sufficient information to know they needed to stop or give way until closer to the crossroad. This highlights the dichotomy of using unusual signage, it likely attracts driver attention but doesn’t impart information about the road ahead as efficiently as familiar signs.

It should be noted that during analysis, a minor error was noted in the placement of the warning sign on the downhill approach crossroad (Middleton Attwell). The warning sign was placed 30-50m closer to the intersection than intended. The result was that it was seen slightly later (2-3 seconds) by participants than intended. Despite this, a significant effect was still seen for the site. Had the sign been placed in the correct location we would have expected an even stronger result. However, given the already high strength, it would not have changed the findings, conclusions, or recommendations.

⁷ As mentioned previously, the warning signs for both Mitigations 1 and 2 were placed 30-50m closer to the crossroad than intended. While the results were still significant, had they been correctly placed, the effect of the mitigations (compared to baseline) may have been even stronger.

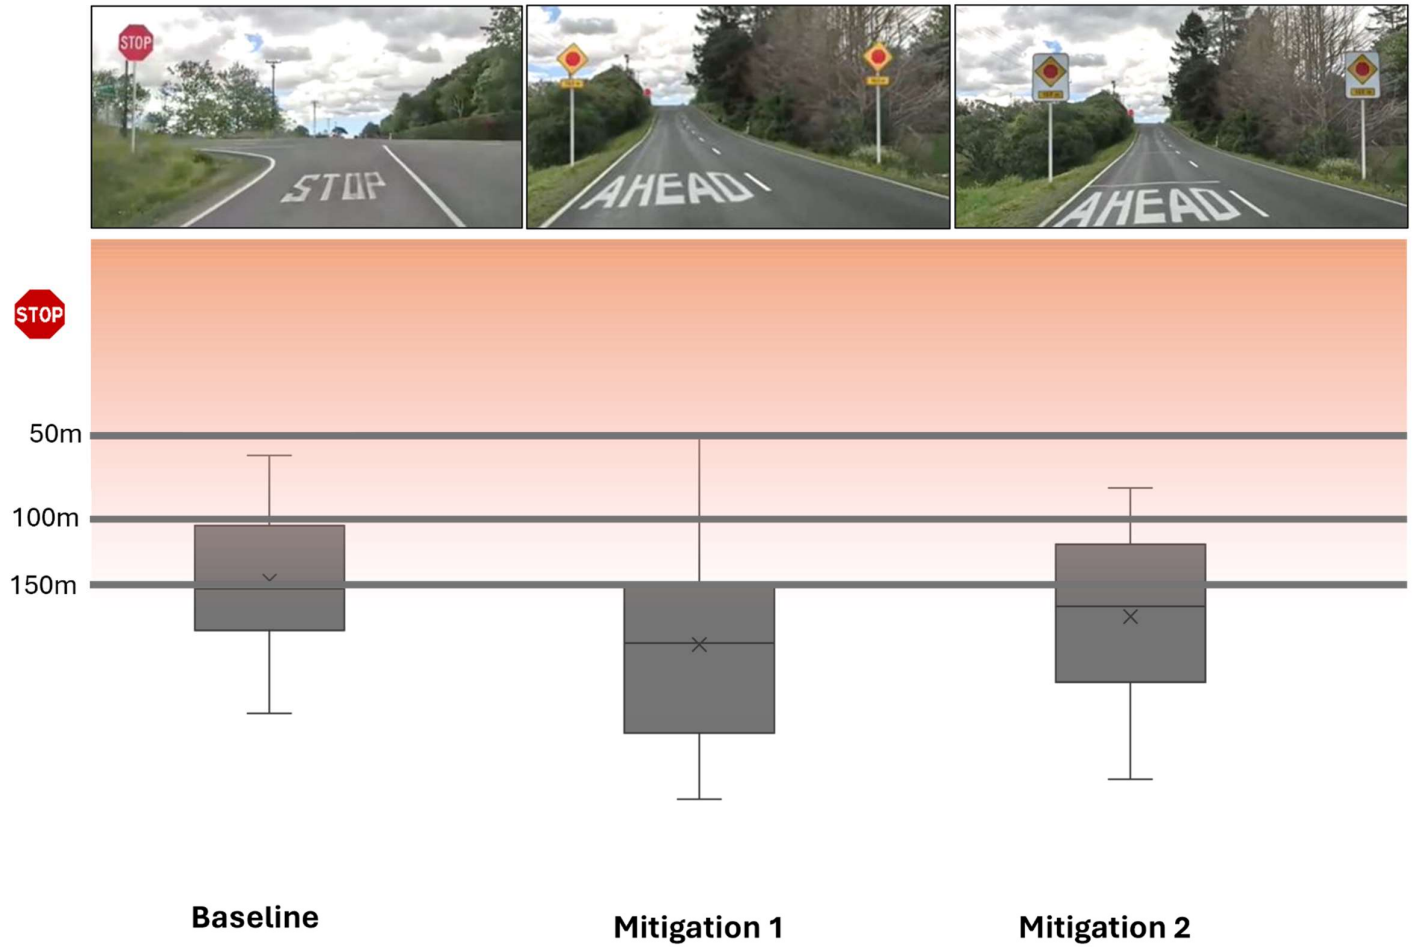
1. Warning signage was set against the rise leading up to the crossroad which meant they were viewed against a heavy tree line.
2. The tree line along the top of the ridge has gaps with light shining through that may have attracted attention away from the warning signage.
3. The right-side oversize stop signs (included in both mitigations) was obscured by trees from the view of the yielding driver. These signs may be a key part of the mitigation. It is possible that the lack of visibility of this component of the mitigation resulted in participants being unsure of the intent of the warning sign until they were much closer than at the other sites.
